## CASE STUDY

Roads | Surface Rehabilitation | Hilton Avenue, KZN

May 2015

Product **Sealmac**<sup>®</sup> | 1400m<sup>2</sup>

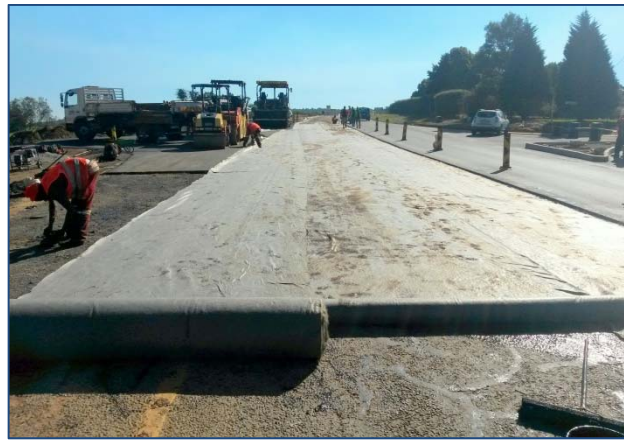
*Sealmac<sup>®</sup> was laid over bitumen on milled surface*

**Sealmac**<sup>®</sup> was installed and paved over with a 50 mm layer of asphalt. The bitumen used for the tack coat was a 3-5% latex-modified cationic emulsion applied at a spray rate of 1.0 l/m<sup>2</sup>. However, due to a shortage of bitumen at the time, some of the **Sealmac**<sup>®</sup> was saturated with a Cat-60 without latex, where the **Sealmac**<sup>®</sup> was already sticking to the surface or where the latex-modified emulsion did not fully saturate the **Sealmac**<sup>®</sup>. The 50 mm layer of medium mix asphalt comprised a 9.5 mm stone with a 5.5% bitumen binder content.

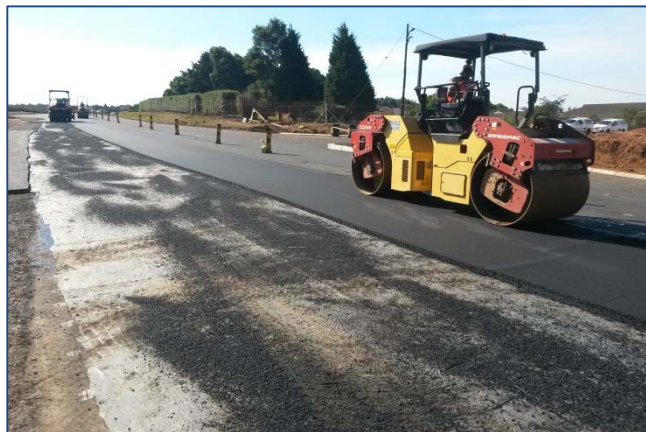
*Gravel spread over Sealmac<sup>®</sup> under a 50mm asphalt layer*

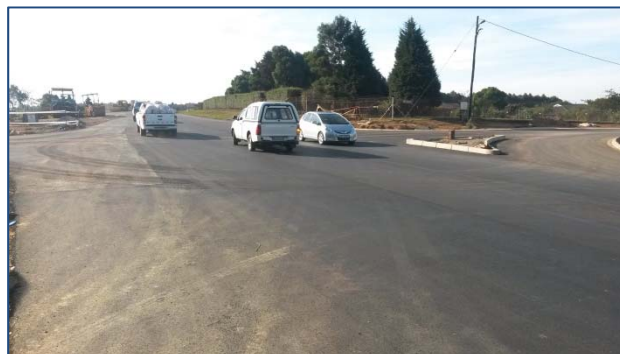
*The repaired road surface*
